Manhole Inspection Summary

Manhole # S13CC1004MH

Insp Date: **1/26/09 12:46 PM**

Location Address: **4054 HILTON RD**

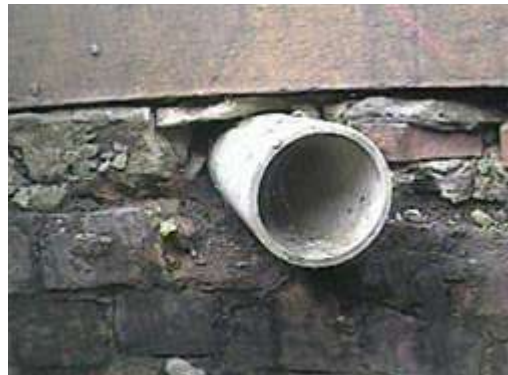
Defect 1

POSSIBLE ILLICIT CONNECTION /
FRAME ADJUSTMENT

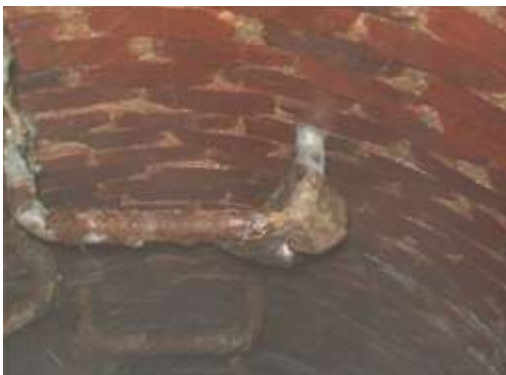
Defect 2

☒ **Evidence Of Surcharge** Depth: **6** (ft.) ☐ Active Surcharge Present

EVIDENCE OF SURCHARGE

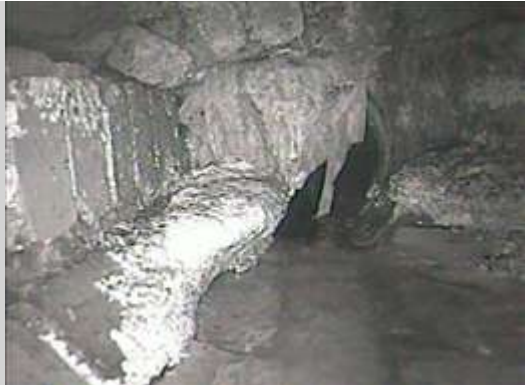
12 O'Clock Outflow

UNABLE TO SEE FULL PIPE CONNECTION
DUE TO DEBRIS

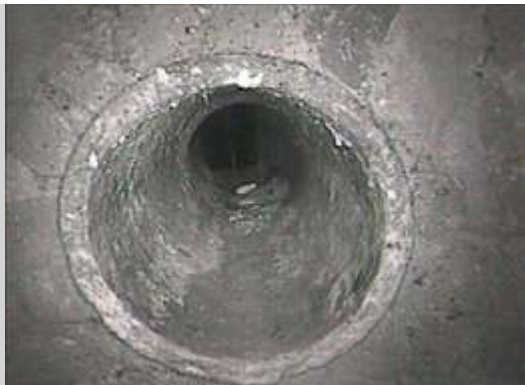
2 O'Clock Inflow

Infiltration: **None** Pipe Seal Cond: **Sound**

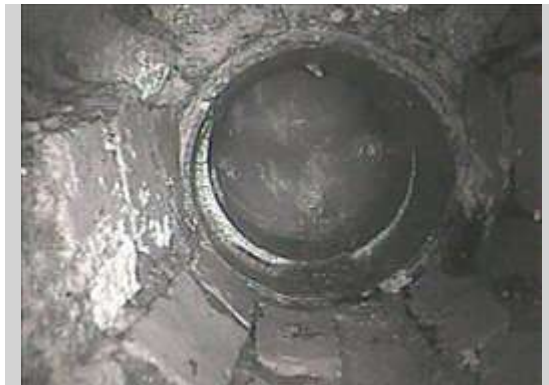
Drop In @ 2 O'Clock

Drop: **Outside Direct**

Drop Condition: **Open**

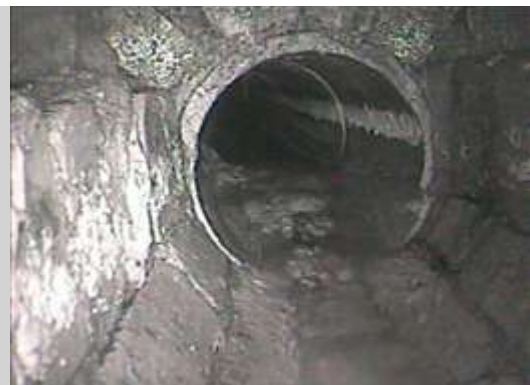
6 O'Clock Inflow

Infiltration: **None** Pipe Seal Cond: **Sound**
